NRC Medium Voltage Circuit Breaker Training

CHAPTER 8

**INTRODUCTION TO
ABB HK
CIRCUIT BREAKERS**

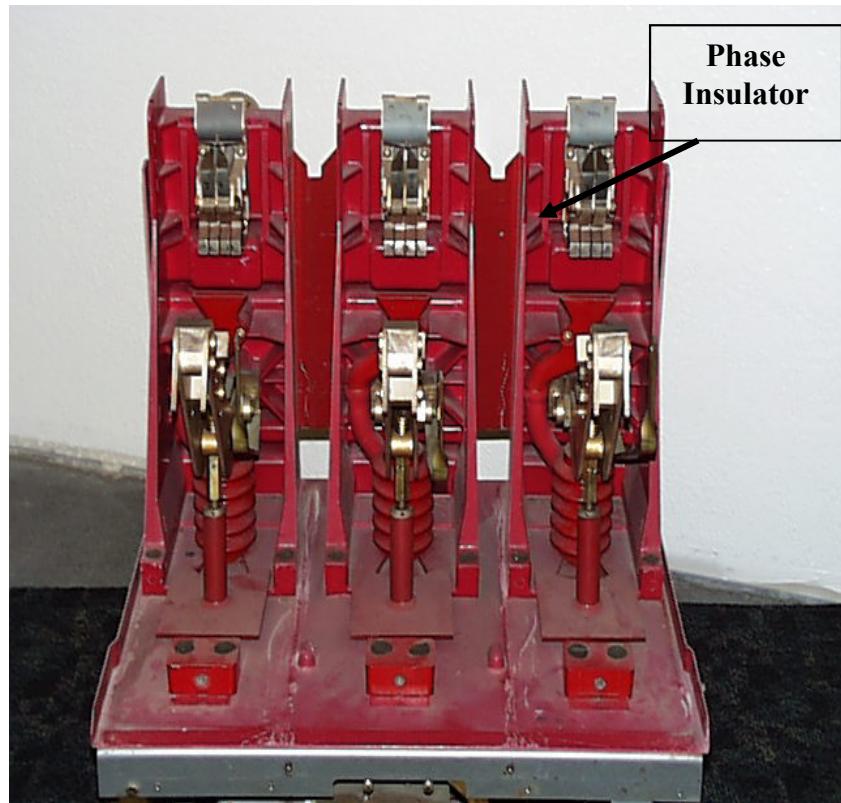
contact assemblies

- Contact.
- Phase insulators

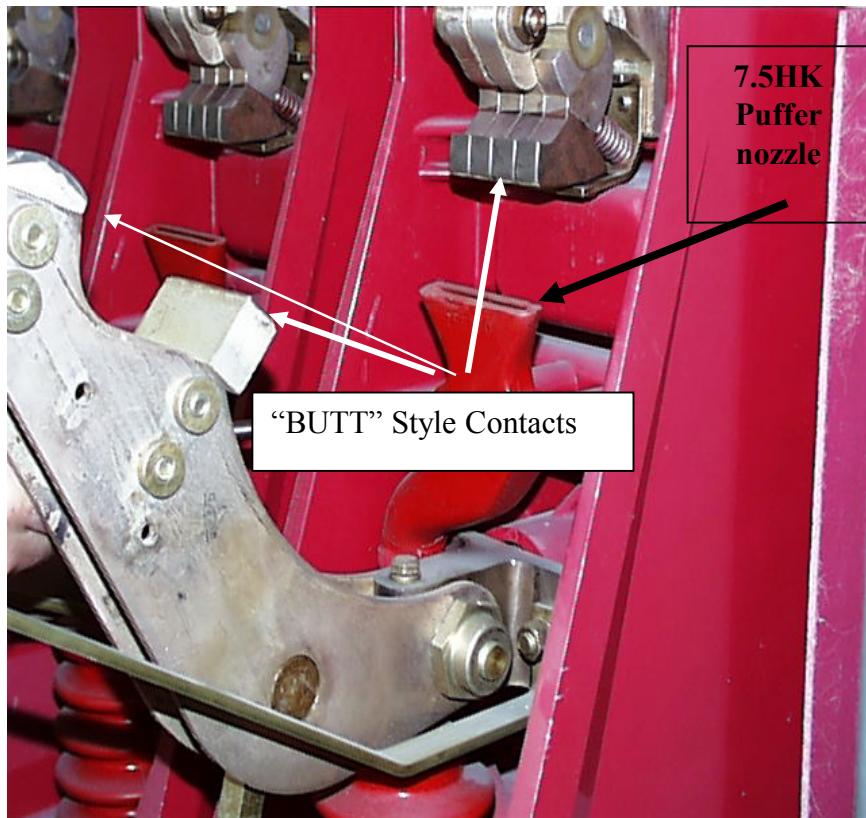
Contacts / Puffer

- The HK contacts are a “BUTT” type design in that they “MAKE” flatly against each other
- The 7.5 HK and above has a single puffer assembly

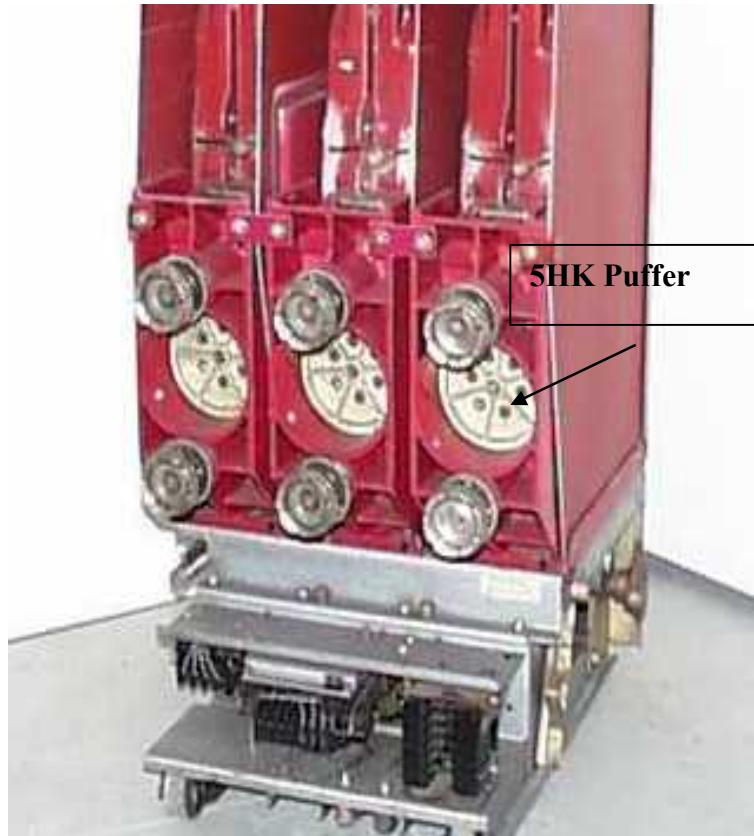
Puffer nozzle

- On a 5HK breaker the puffer is part of the moving contact assembly with an individual puffer for each phase

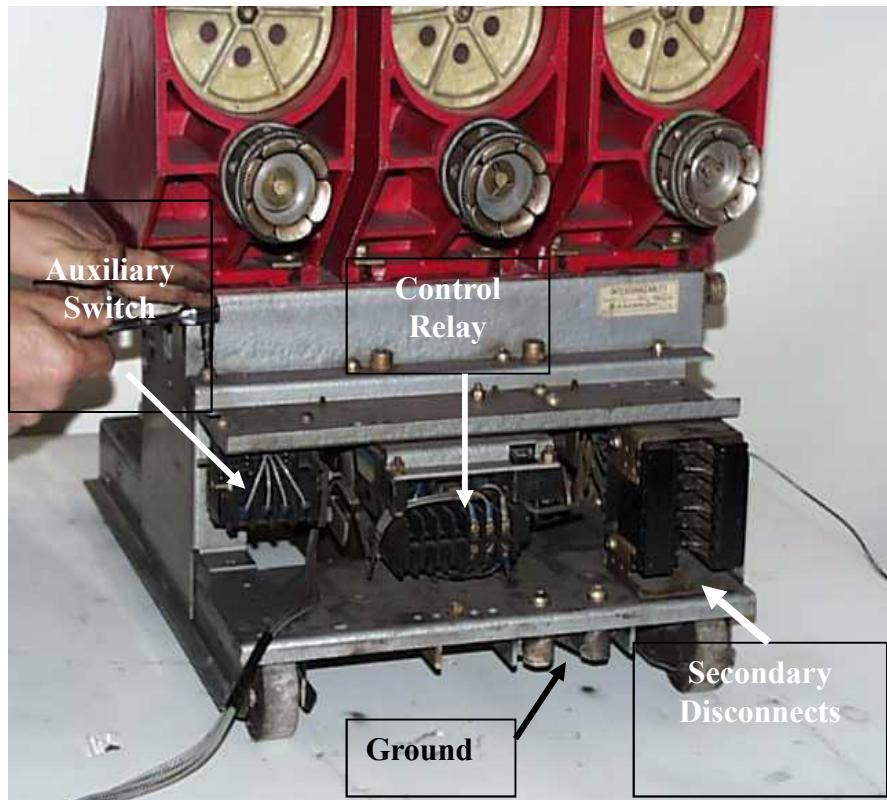
Electrical Devices

- Auxiliary switch
- Control Relay
 - MCO (Motor Cutoff)
 - Anti-Pump protection for the breaker
- Secondary disconnect

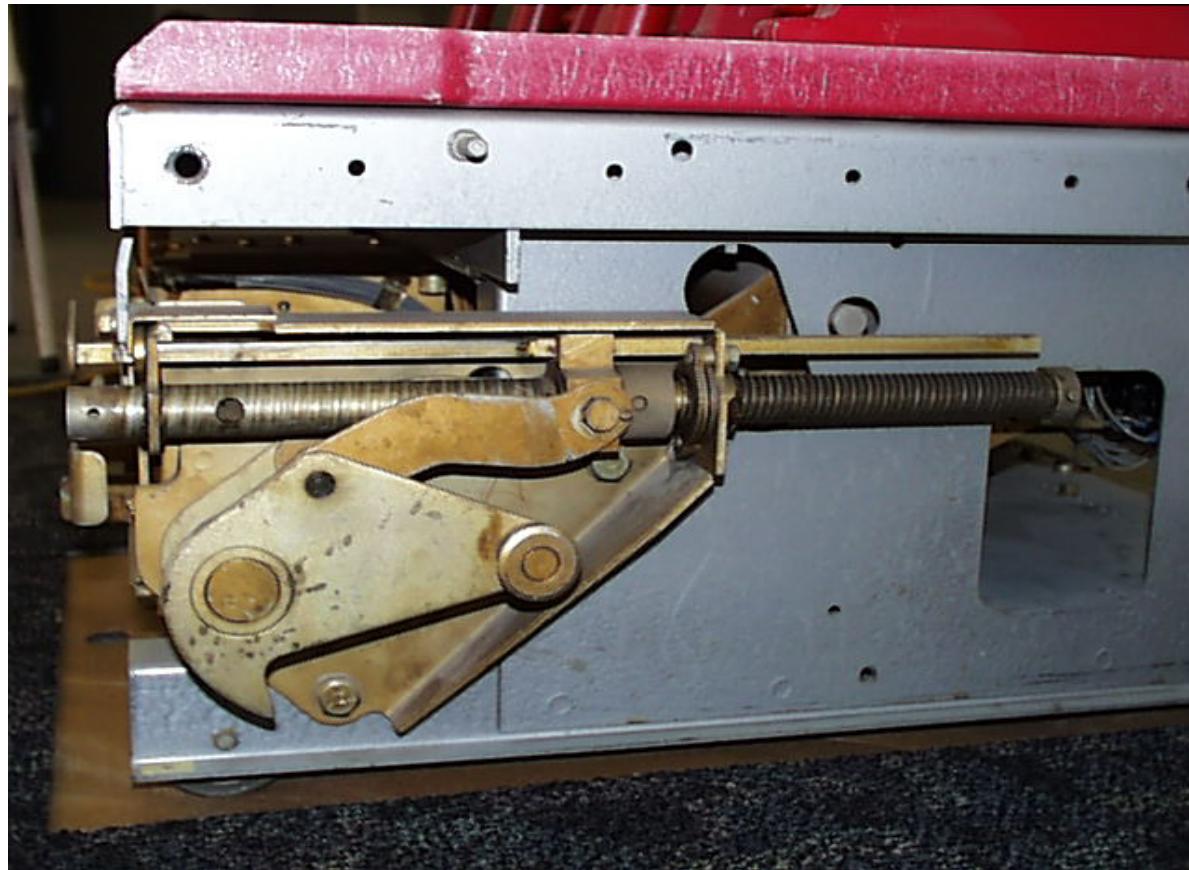
Racking Device

Racking operation and safety Interlocks.
